Ōrākei Basin State of the Basin Monitoring Report 2018

Parks, Sports and Recreation
July 2018

Auckland Council

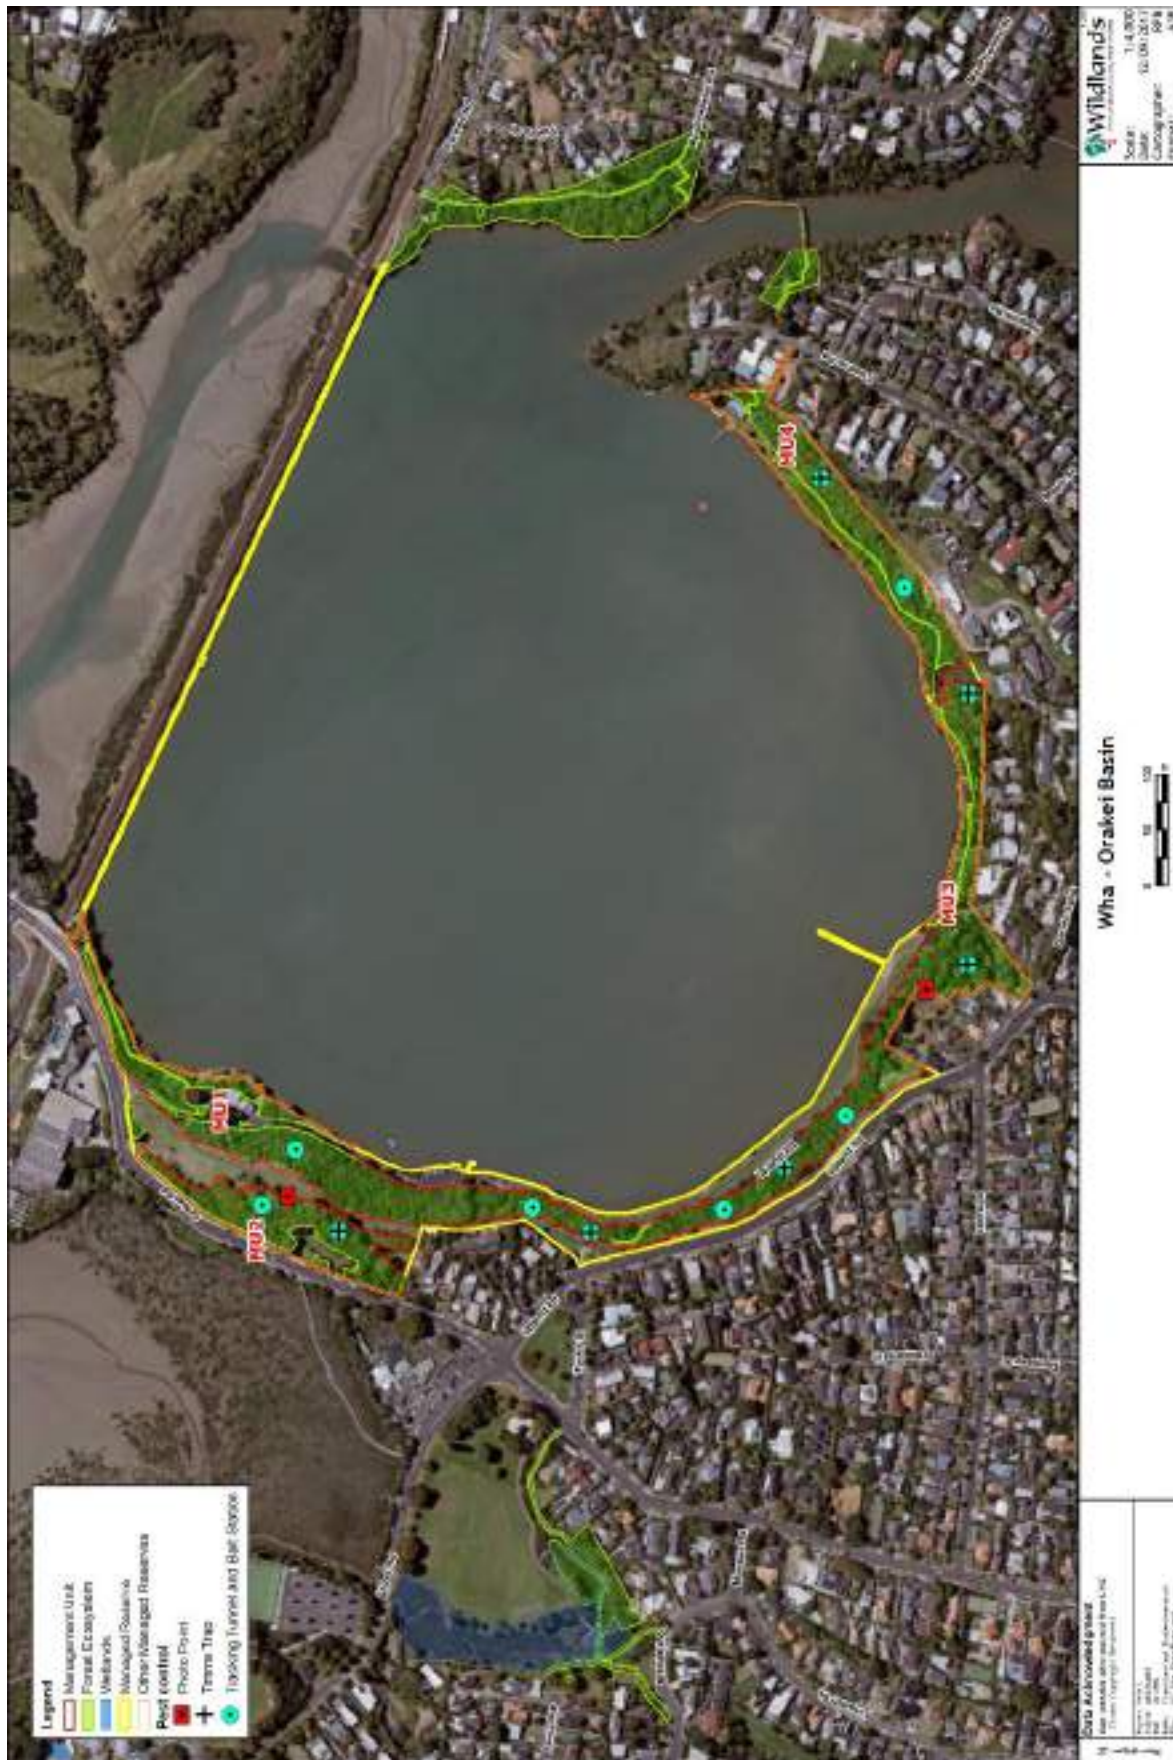
Wildlands Consultants completed a Site Assessment Report in October 2017 for Ōrākei Basin. The plan outlines planned pest plant maintenance and ecological enhancement activities over coming years. The Basin is segmented into four management units as shown below.

Figure 2: Ōrākei Basin management units for Ecological Restoration contract

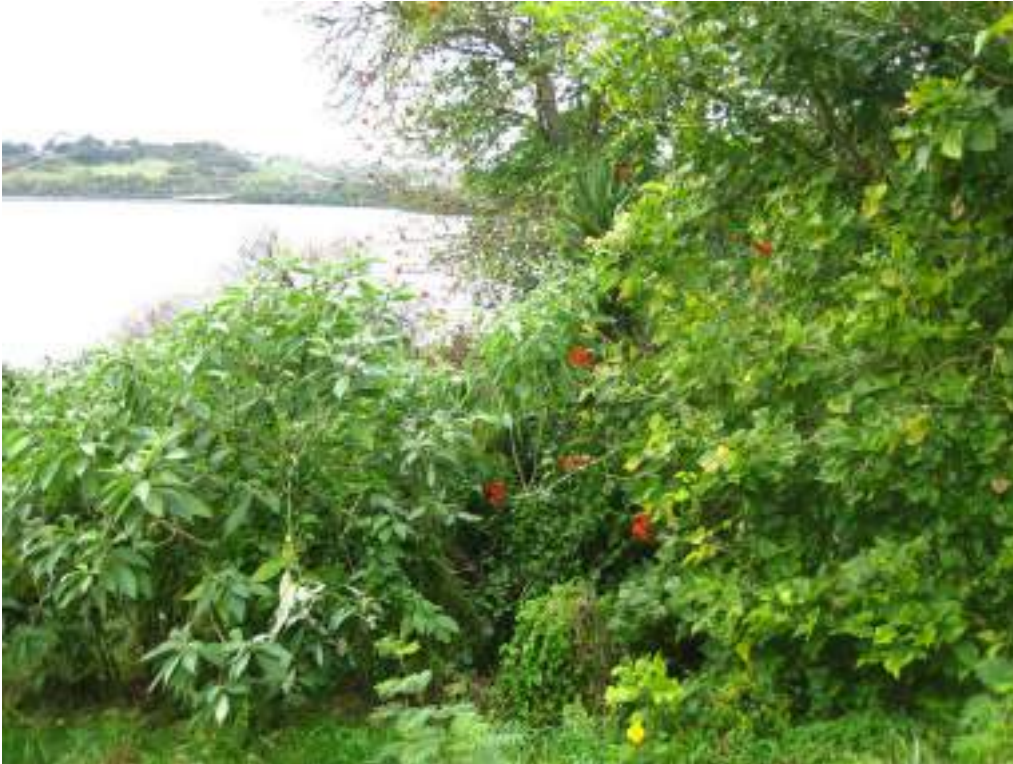
Figure 3: Photopoint 1. Madeira vine, woolly nightshade, and mature coral tree. MU3, Ōrākei Basin Reserve. 5 July 2017

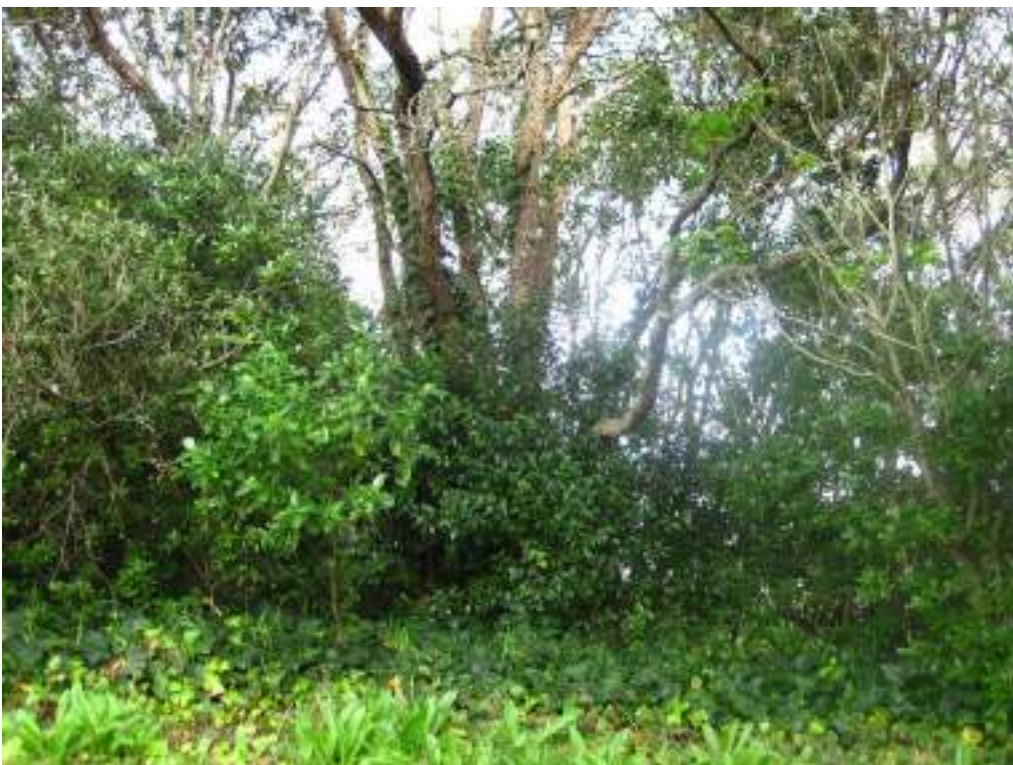
Figure 4: Photopoint 2. Tree privet and English ivy infestation. MU2, Ōrākei Basin Reserve. 5 July 2017

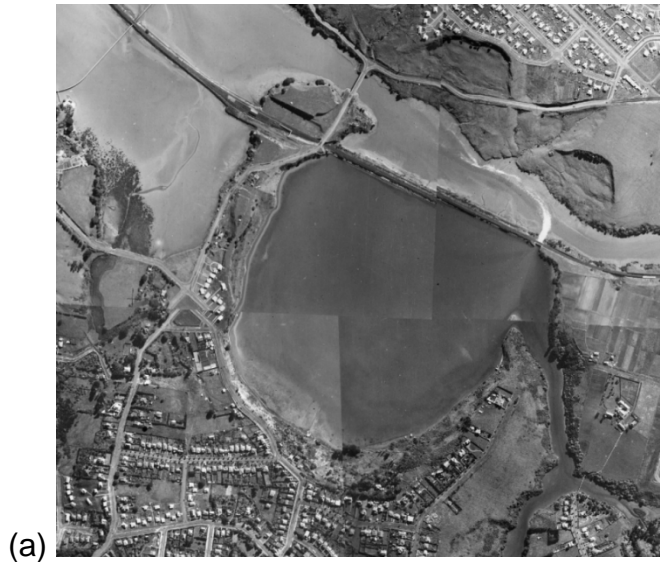
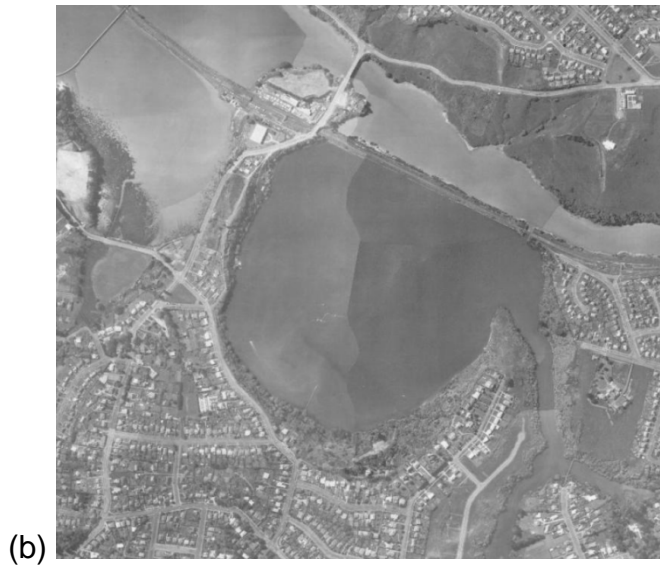
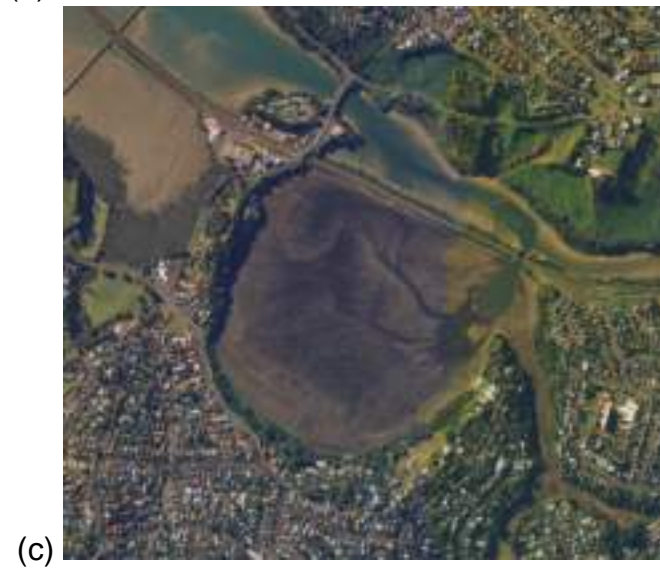
After 1840 the development of the Auckland isthmus intensified and this resulted in widespread clearance of native vegetation to provide land for housing, gardens and pasture. The earliest aerial photographs of the Basin - taken in 1940 - show a landscape with almost all forest and scrub vegetation removed (Figure 5a); just grassland and small, patchy areas of fernland with a few scattered shrubs remain. Nineteen years later aerial photographs show taller stature vegetation beginning to return to the steeper slopes facing the Basin, particularly along the southern and south-western margins (Figure 5b). By 1996 this band of mixed forest and scrub had thickened and grown in stature (Figure 5c) and this is the core of the forest habitat that remains around the Basin today.

Figure 5 : Ōrākei Basin a) 1940, b) 1959, c) 1996 aerial imagery

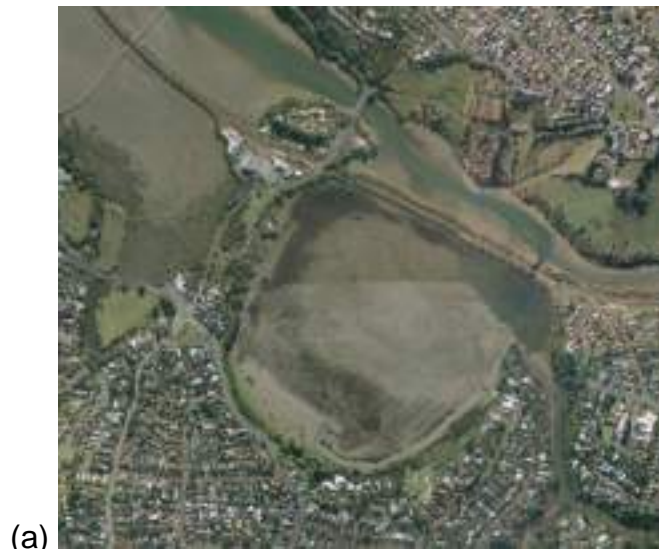
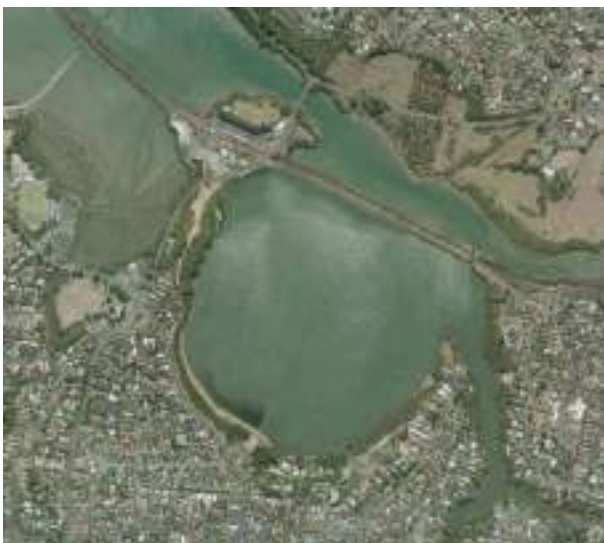
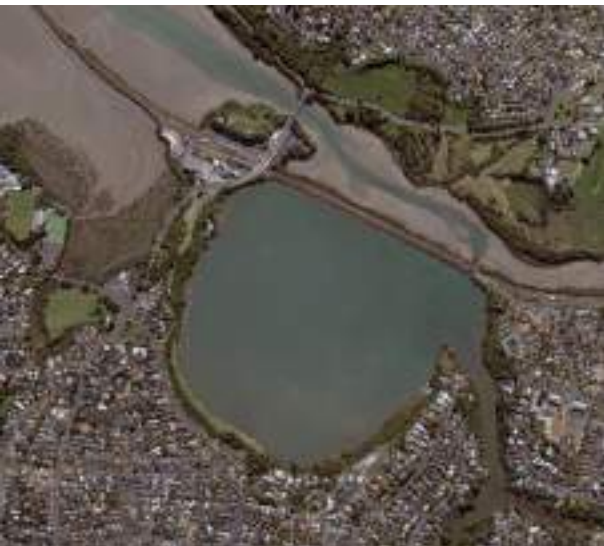
Figure 6: Ōrākei Basin a) 2001, b) 2010/11, c) 2016 aerial imagery

In the 1990s a large number of weedy exotic trees were removed from the vegetation along the western margin of the Basin, and indigenous trees and shrubs planted to replace them. This restored habitat has continued to grow in stature, density and species richness through the early part of the 21st century (Figure 6 a, b and c).

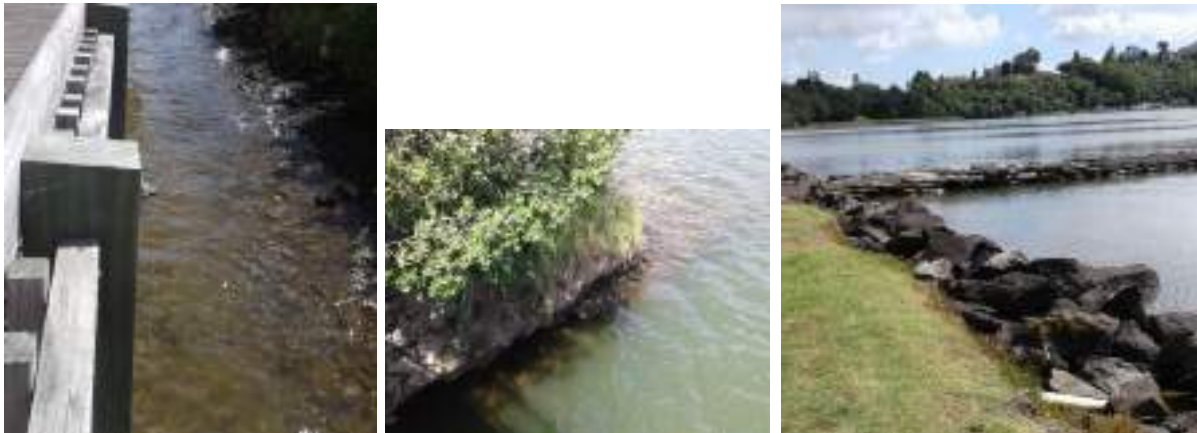
Figure 8: Intertidal and subtidal environments of the Basin.

The restriction of tidal flow into the Basin could cause the reduction in larval movement and recruitment from within and outside the Basin. It could also reduce the number of species, such as fish, moving from outside the Basin into the Basin.

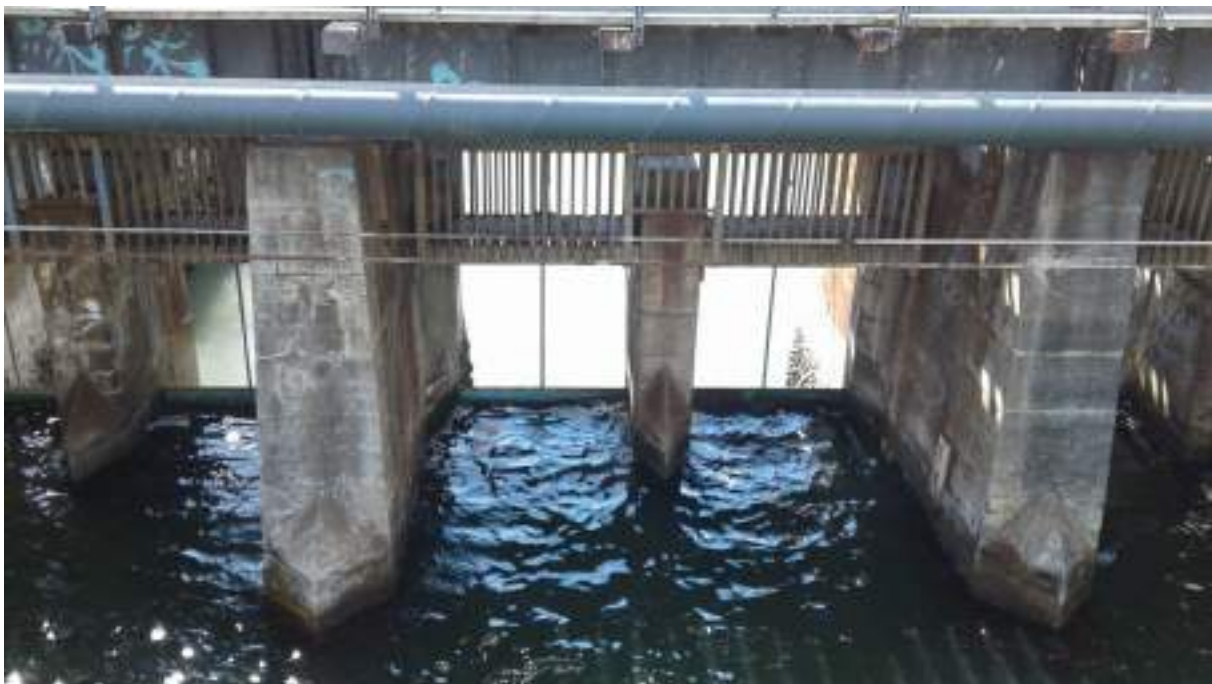
Figure 9 : The gates which control the water level of the Basin.

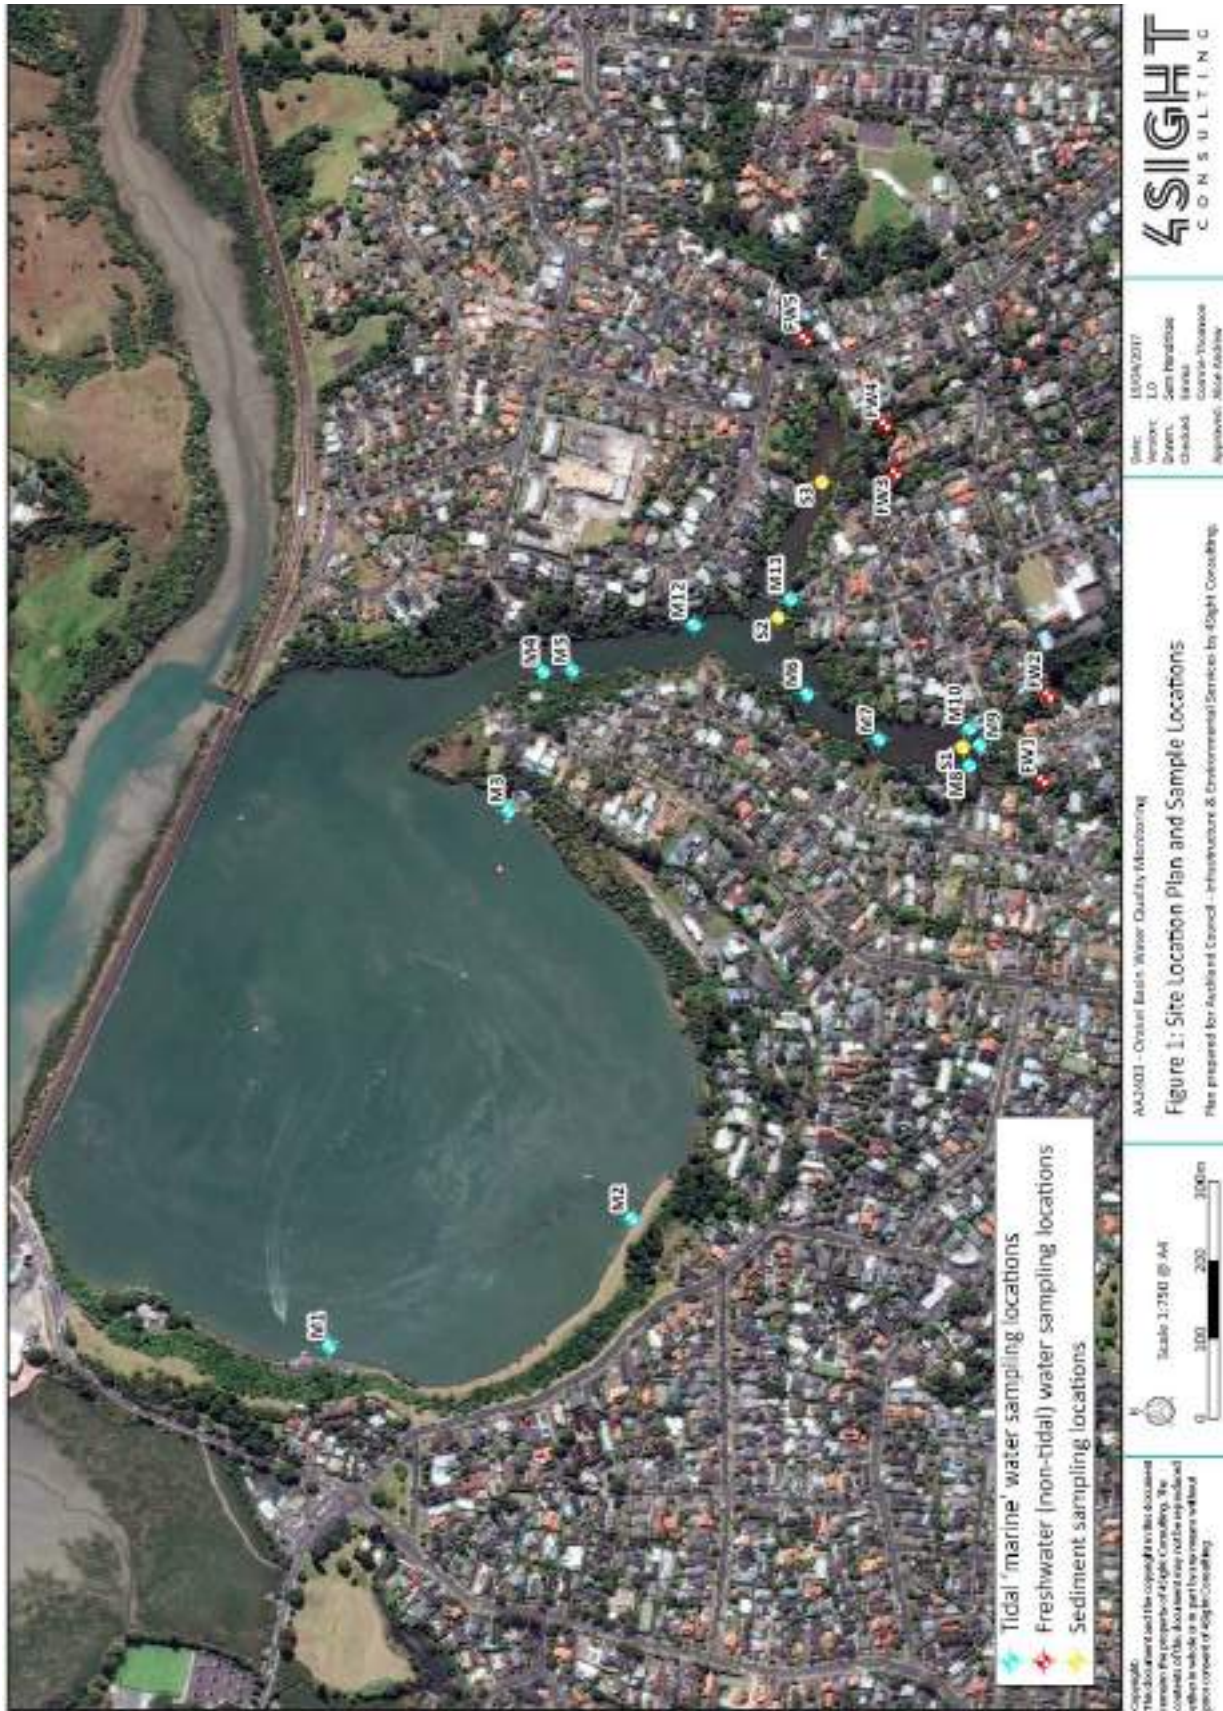
Figure 10. Map of water sampling locations throughout the Ōrākei Basin and freshwater creeks. Sample locations starting with M denote the marine sites (n = 12); FW indicates freshwater sites (n = 5).

Water samples collected from the marine sites (M1-M12 see Figure 10 for the map of testing sites) showed that *Enterococci* levels were below alert levels during dry weather conditions at sites within the Basin and in the proximal Basin arm (Figure 11). However, sites further up the Basin arm were near or above alert levels. During light rain events, only the three sites within the Basin were below alert levels while the rest of the sites exceeded guideline levels. Only one site remained below alert levels during heavy rain events, and 11 exceeded guideline levels (Figure 11). To put these results in context, the highest concentrations recorded were 400-500/100mL where raw sewage can be 24,000/100mL and upwards.

All water samples collected from the freshwater sites (FW1-FW5 on the map; Figure 10) exceeded guideline levels for *E. coli* regardless of when the samples were collected. Understanding the source of *E. coli* at these sites could help to identify how best to mitigate these polluted water quality conditions. The source of the freshwater within the Ōrākei Creek is Waiatarua Wetland which drains through an extensive pipe system from the wetland under St Johns Road. Additional water quality testing conducted by 4Sight in the Orakei Basin in 2018 showed that enterococci levels continually exceeded thresholds at most marine sites (not M1, M2, and M3), and

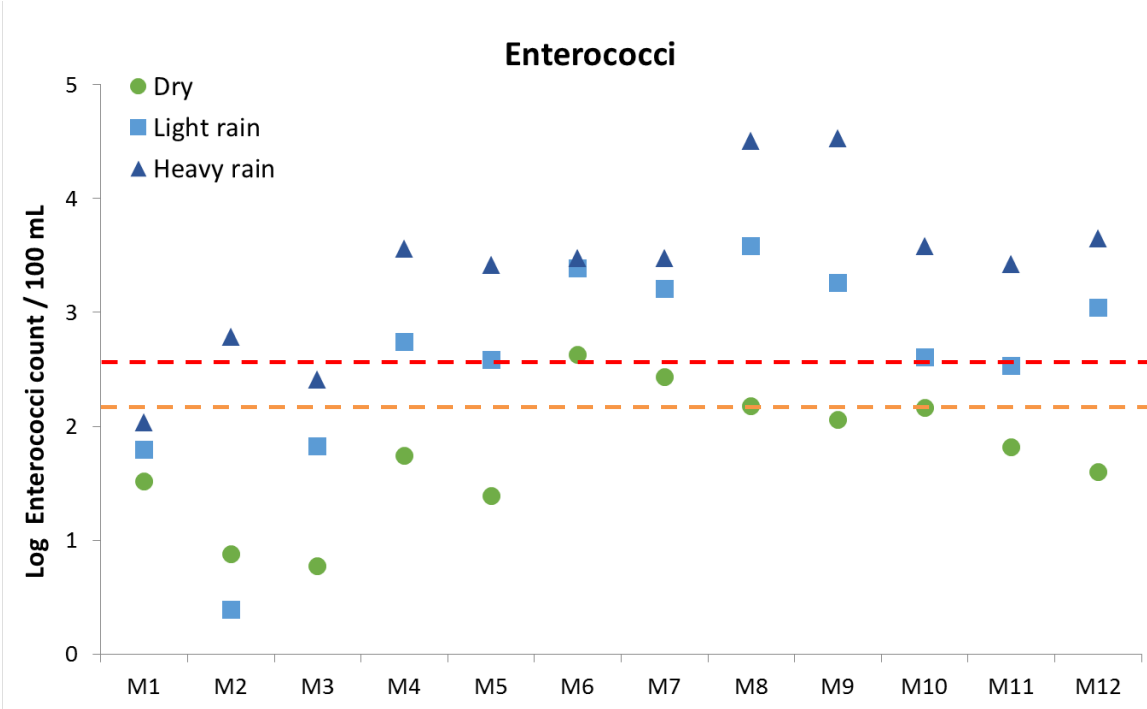
Figure 11. *Enterococci* counts per 100 mL for samples collected during dry weather (green circles), light rain (light blue squares), and heavy rain (dark blue triangles) at the 12 marine sites. The dashed lines represent warning levels for *Enterococci* counts: above the orange and below the red line indicates potentially contaminated conditions; counts above the red line indicate contaminated water.

Because *Enterococci* and *E. coli* counts are particularly high following rain events (light or heavy), we recommend allowing the Basin to flush following these events for multiple days. This will likely reduce the residence time of harmful bacteria levels in areas where people and animals are in contact with the water.

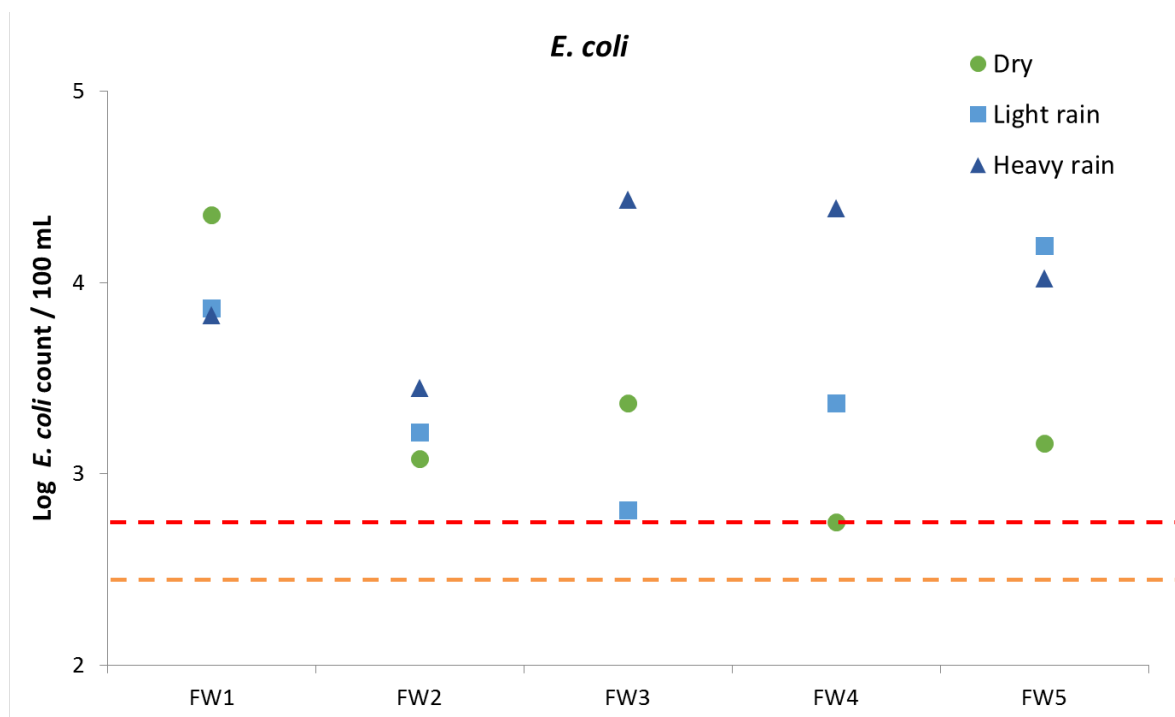
exceeded *E. coli* thresholds at all freshwater sites except F5. Microbial source tracking analyses on the samples also revealed that the source of faecal bacteria is mainly human. Contamination from dogs was found in about half of the samples and the incidence of contamination from waterfowl was low.

Figure 12. *E. coli* counts per 100 mL for samples collected during dry weather (green circles), light rain (light blue squares), and heavy rain (dark blue triangles). The dashed lines represent warning levels for *E. coli* counts: above the orange and below the red line indicates potentially contaminated conditions; counts above the red line indicate contaminated water.

- Ongoing sampling should continue to target various weather conditions. It would also be useful to know how long conditions exceeding guideline levels persist at the various sites so the effects of flushing can be measured.
- Key sampling would be to continue monitoring for *Enterococci* and *E. coli* during the weeks that the Basin is in high recreational use.

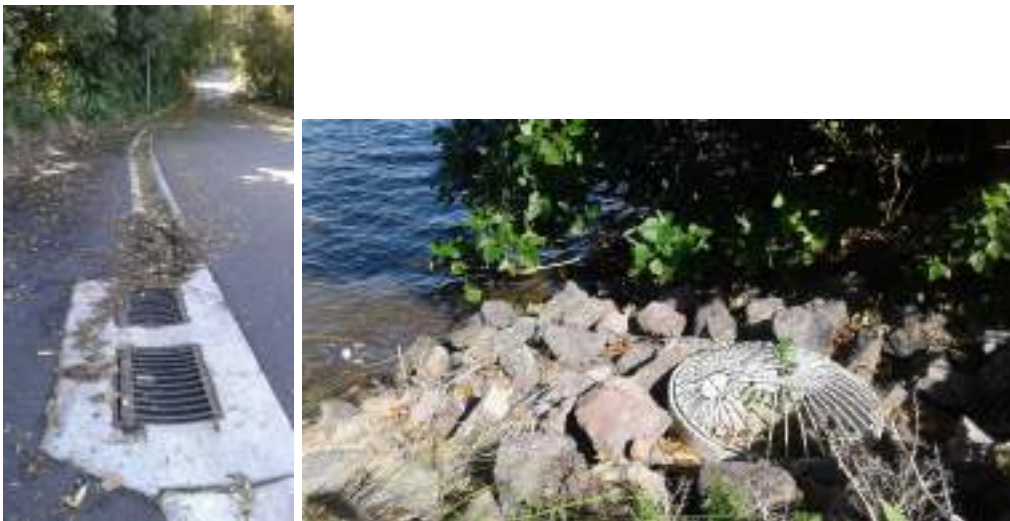
A number of silt mitigation devices are provided within the internal road, car park, and walkway areas of Ōrākei Basin. Catchpits, dish channels, and bubble up chambers within the reserve are maintained via the Community Facilities Full Facility Maintenance contract, which ensures a basic level of maintenance (debris removal, clearing blockages) is undertaken. Consideration of stormwater infrastructure within the wider stormwater catchment is not considered in this report. Auckland Transport and Healthy Waters have maintenance responsibilities for this infrastructure in the wider network in the road corridor and stormwater treatment ponds which feed in to Ōrākei Creek and Ōrākei Basin.

A visual inspection of a number of the park assets within the Basin road and walkway network completed in March 2018 indicated that the existing infrastructure is maintained sufficiently.

Figure 13: Stormwater devices in Ōrākei Basin West Reserve

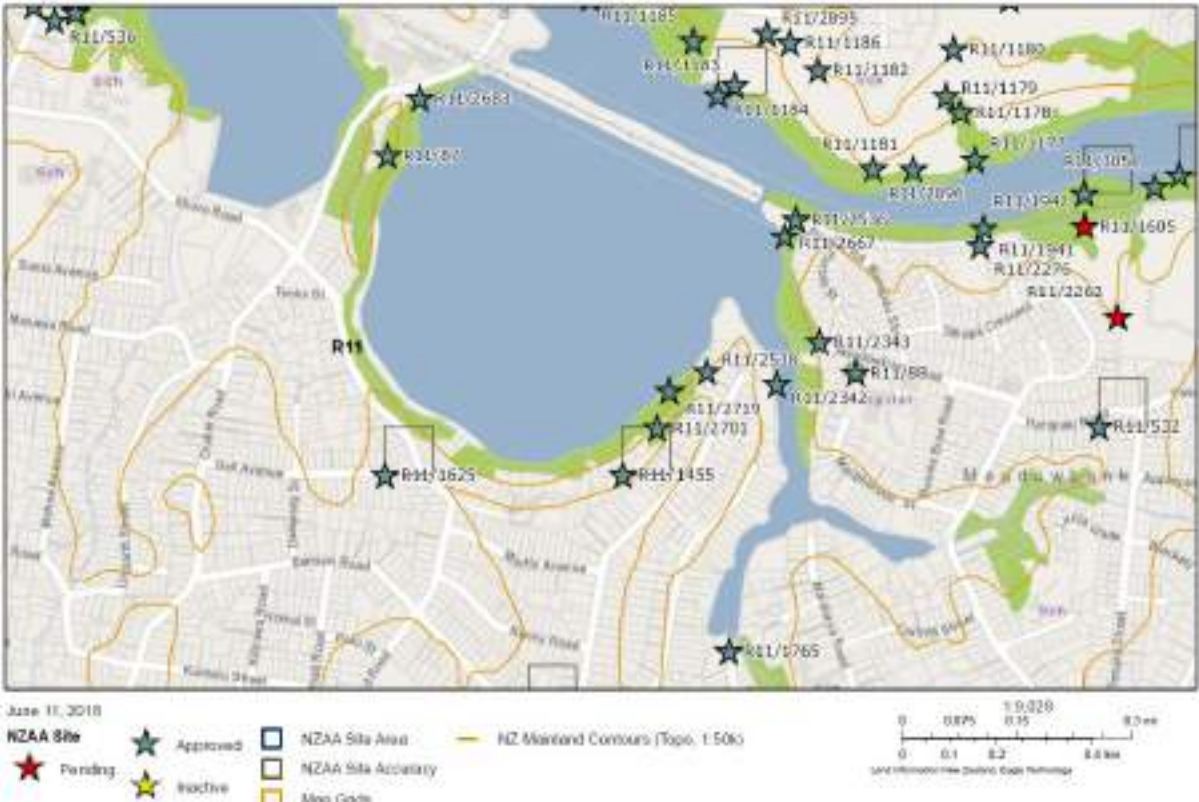
Figure 14: Recorded archaeological sites within Ōrākei Basin (ArchSite, June 2018)

A baseline survey has been completed in March 2018 of the five listed sites by Heritage Unit staff at Auckland Council. Of the five, two were badly degraded (R11/2343 and R11/2538 – both midden sites); one was inaccessible (R11/2536 – midden); and two were in moderate condition (R11/87 and R11/1765 – pa and midden respectively). Condition monitoring forms were completed for all five scheduled sites and are included in Appendix A.

Management recommendations have only been able to be provided for the two extant and accessible sites (R11/87 and R11/1765). The two destroyed sites have been affected by park upgrade works and general erosion and wear and tear. The inaccessible site has been damaged but seems relatively secure in its location within the rail corridor.

- R11/1765 (Kelvin Reserve) – do nothing. The site appears to be intact and in good condition. It is secure as a subsurface deposit with no significant threats other than gradual fluvial erosion at the toe of the headland on which it is situated, and potential vegetation removal. In short, if Kelvin Reserve stays as

- R11/87 (Ōrākei Pa) – amend operational mowing maintenance practices and provide interpretation signage. Site R11/87 has significant potential for information signage to enhance the site as a heritage destination within the reserve area. The site has been historically damaged and its features are now quite obscure but there is enough left on the ground to highlight as a feature.

- It is recommended that monitoring forms are completed for the five additional sites, and they be incorporated into any future update of the management plan.
- Undertake archaeological assessments during any developments so that any evidence is recorded.

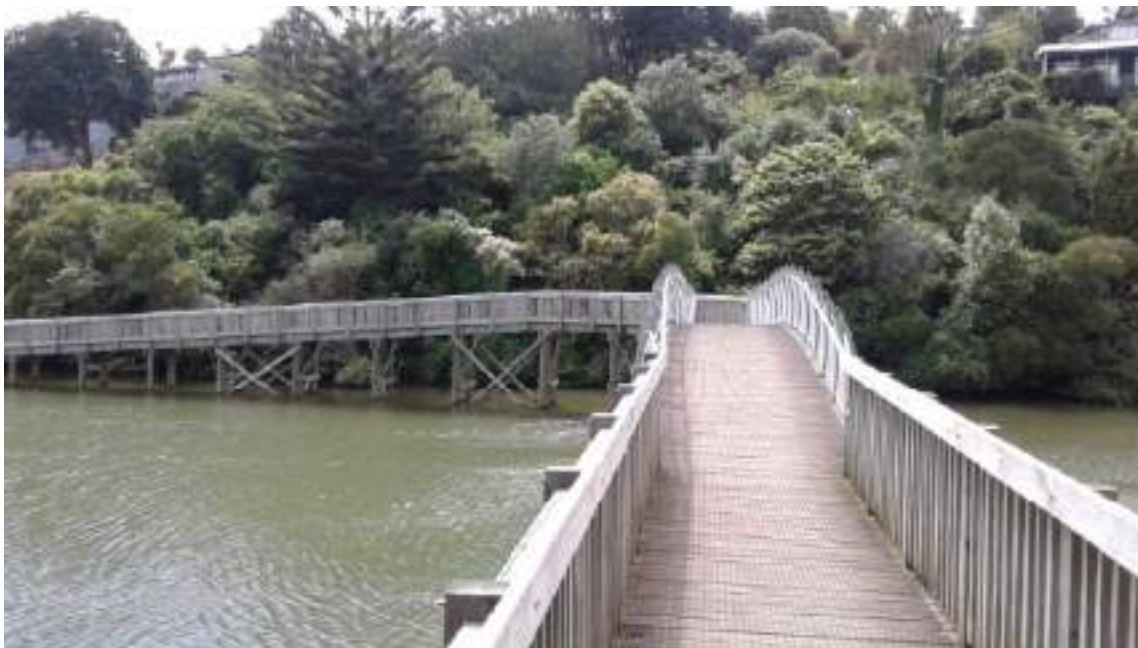
The consented walkway loop track and pedestrian bridge across Ōrākei Creek were completed in 2011/12 and enable a continuous loop walk around the Basin. The boardwalk along the rail embankment was completed as a shared cycle / pathway in November 2010. Ōrākei

Figure 16: Pedestrian bridge across Ōrākei Creek
